Re: NPDES Compliance Evaluation Inspection at Atlanta Gold Corporation located in
Atlanta, Idaho

***National Pollutant Discharge Elimination System
(NPDES) Inspection Report***

***Atlanta Gold Corporation
Atlanta, Idaho
NPDES Tracking #IDG910006***

The facility tour was centered on the 900 Level Adit associated wastewater treatment facility. Photographs taken during the inspection can be found in Attachment B, Photograph Log.

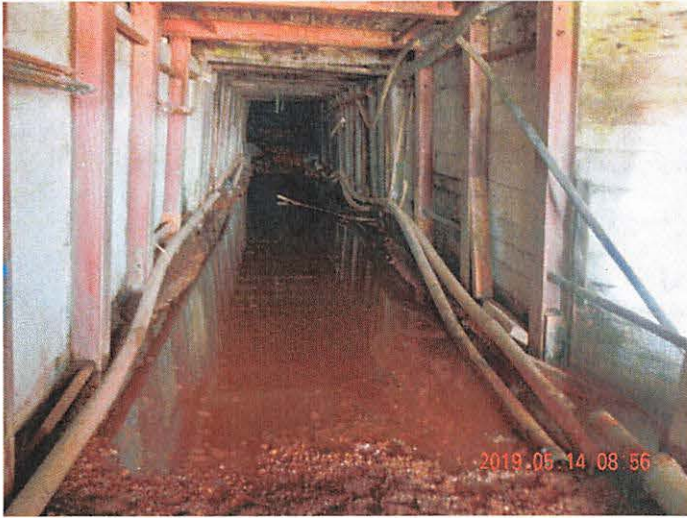
Photo #:01 (DSCN1722)

Description: Facing south, photo from just inside the 900 Level Adit.

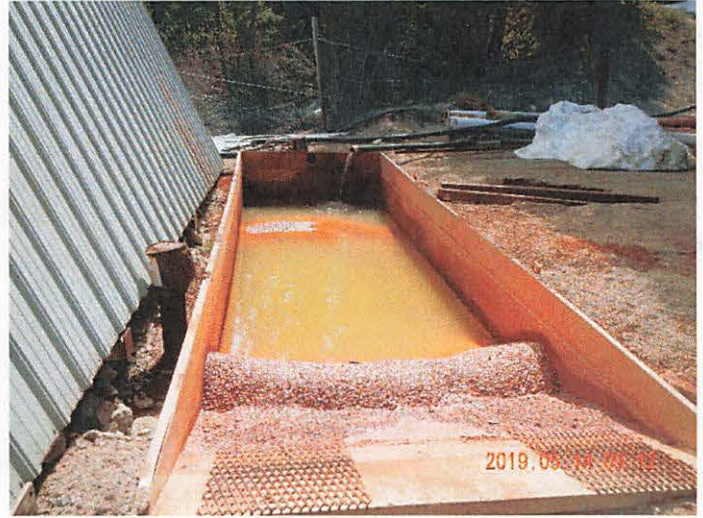
Photo #:02 (DSCN1723)

Description: Facing east, photo of Tank #5 at the time of inspection. Tank #5 is filled with 3/8-inch gravel and receives water via the utility line behind the stub wall. Tank #5's primary use is for settling solids.

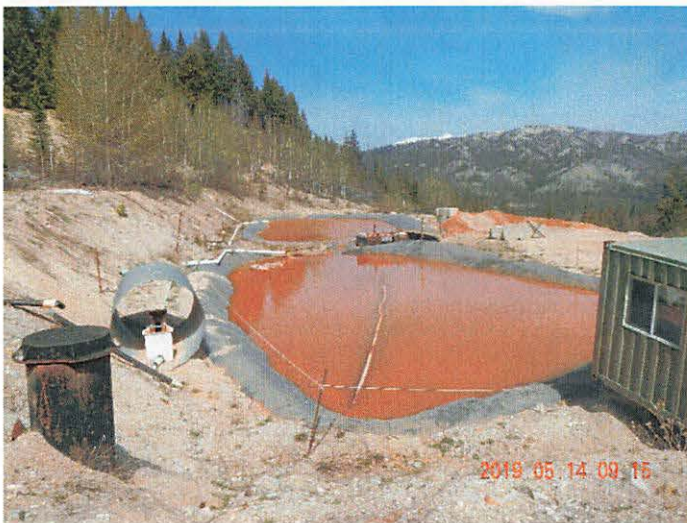
Photo #:03 (DSCN1724)

Description: Facing northwest, photo of Pond #1 (North Pond) and Pond #2 (South Pond).

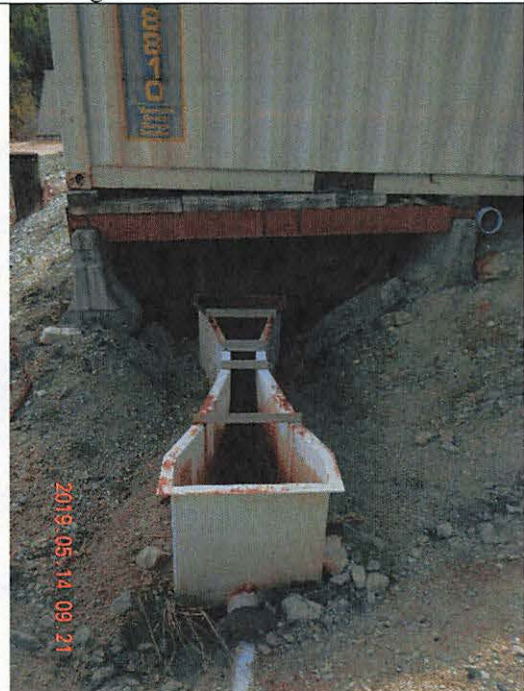
Photo #:04 (DSCN1725)

Description: Facing southeast, photo of the upper Parshall Flume used for a portion of the influent flow monitoring. The upper Flume receives adit water from the sump and directs flow to Pond #1 and/or Pond #2).

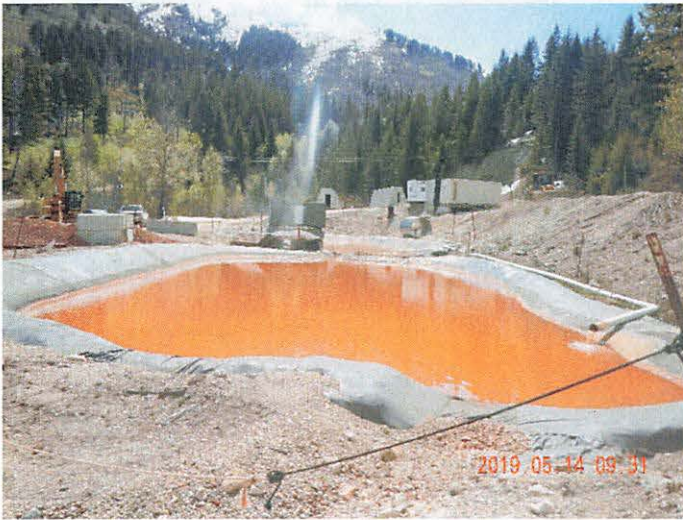
Photo #:05 (DSCN1726)

Description: Facing south, photo of Pond #1 (North Pond).

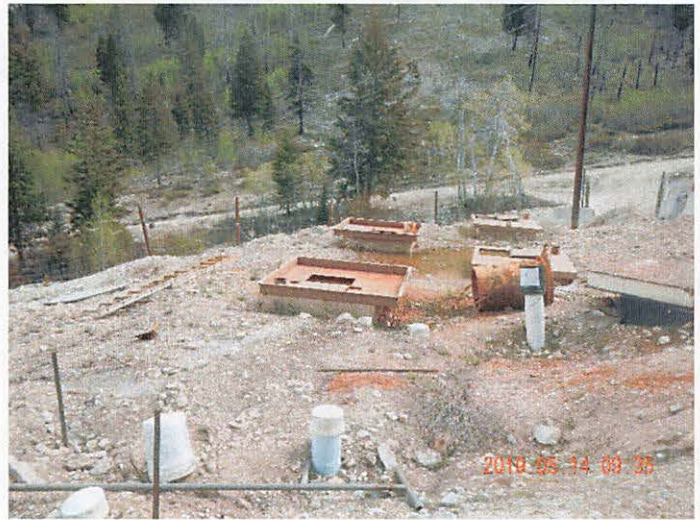
Photo #:06 (DSCN1727)

During the facility tour, we observed Tank #1 (cell #1) and Tank #2 (cell #3) to be at maximum capacity; water was overflowing from the top of Tank #2 (cell #3) and was infiltrating nearby. At the time of inspection, Mr. Inama stated that the overflow was discovered earlier that morning during his routine site visit, he stated he hadn't had a chance to investigate the issue yet due to the EPA inspection, but most likely filter material got dislodged with the observed high flow coming from the adit and was restricting flow between the two cells within the tanks.

Description: Facing east, photo of showing access portals to underground Tanks #1 and #2. Tank #1 (left) cells 1 & 2, Tank #2 (right) cells 3 & 4. Water from Tank #2, Cell 3 was overflowing and infiltrating at the time of inspection.

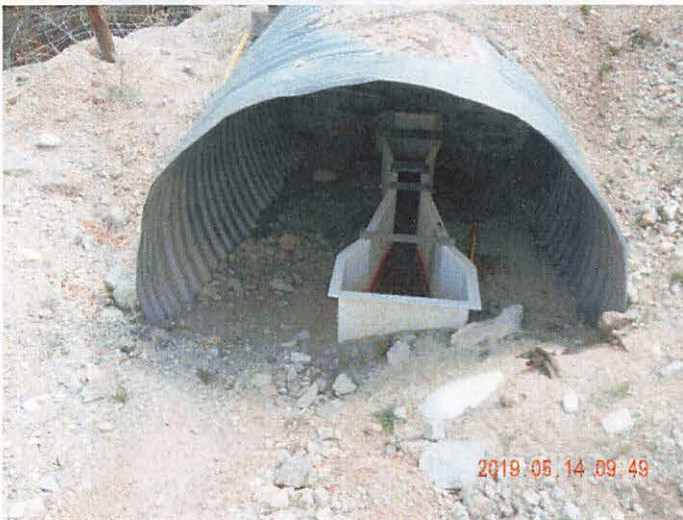
Photo #:07 (DSCN1728)

Description: Facing east, photo of the effluent Parshall Flume.

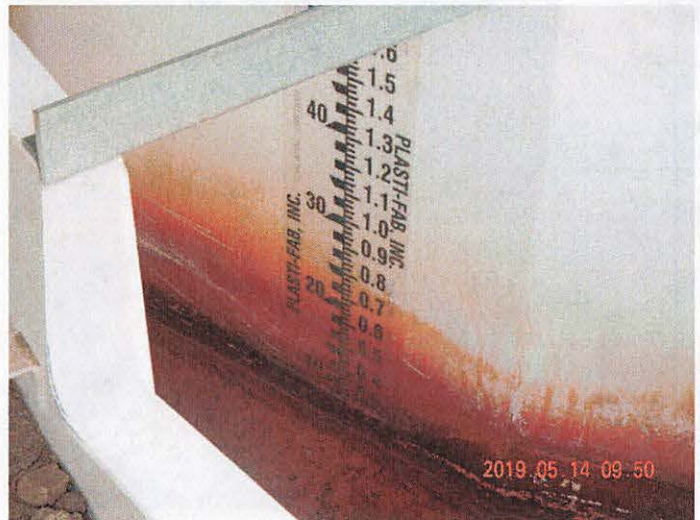
Photo #:08 (DSCN1729)

Description: Photo of the measurement chart on the effluent Parshall Flume.

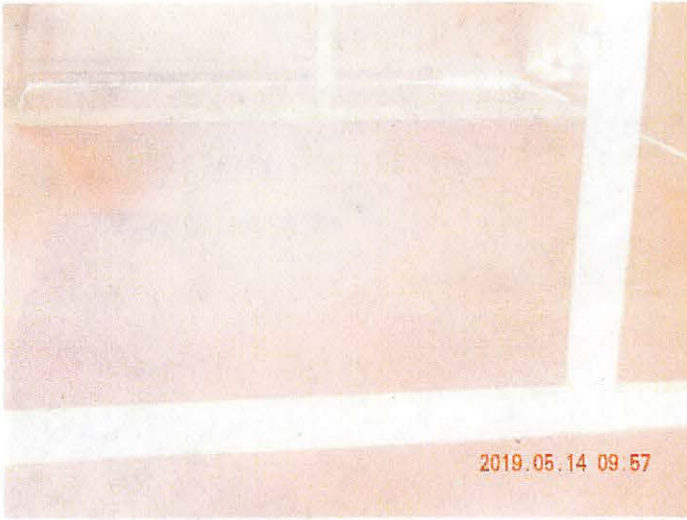
Photo #:09 (DSCN1730)

Description: Photo of inside Tank #3. Material includes filter fabric, 3/8-inch gravel, and silica sand.

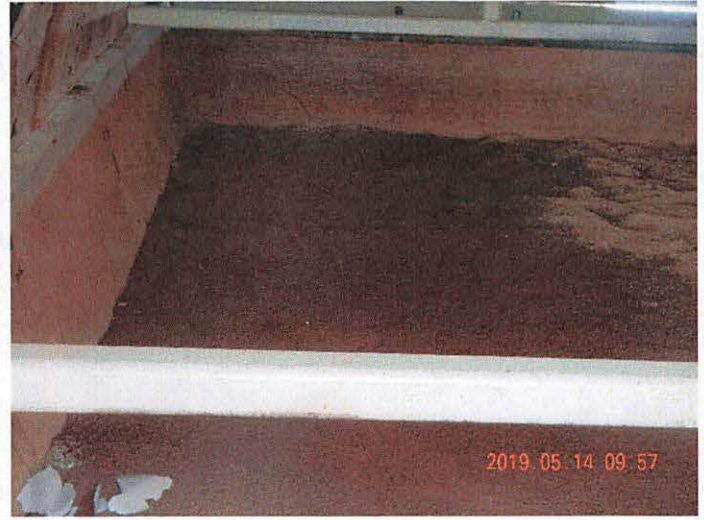
Photo #:10 (DSC1731)

Description: Photo of inside Tank #3. Material includes filter fabric, 3/8-inch gravel, and silica sand.

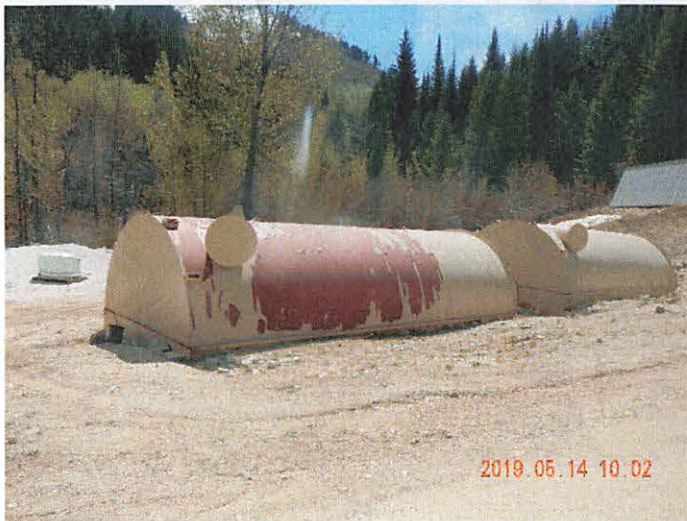
Photo #:11 (DSCN1732)

Description: Facing southeast, photo of Tank #3 (right) and Tank #4 (left).

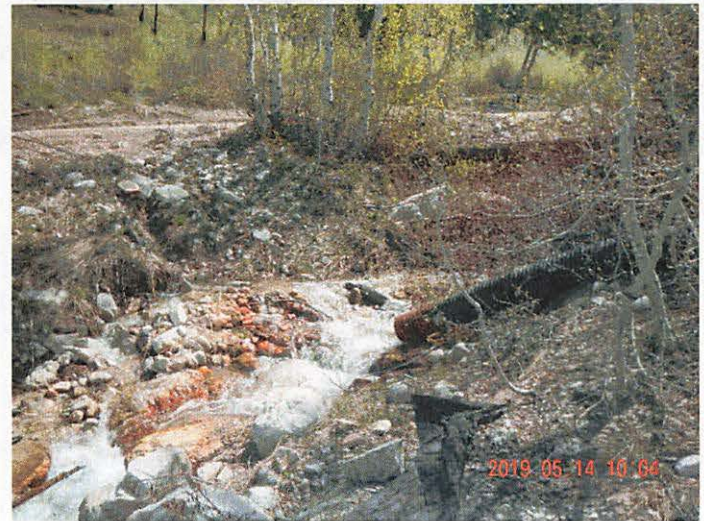
Photo #:12 (DSC1733)

Description: Facing southeast, photo of the effluent discharge into Montezuma Creek (Outfall 001).

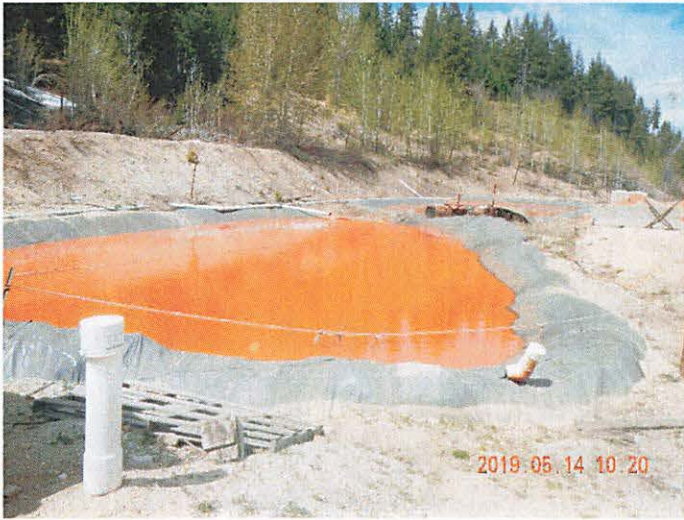
Photo #:13 (DSCN1734)

Description: Facing west, photo of Pond #2 (South Pond).

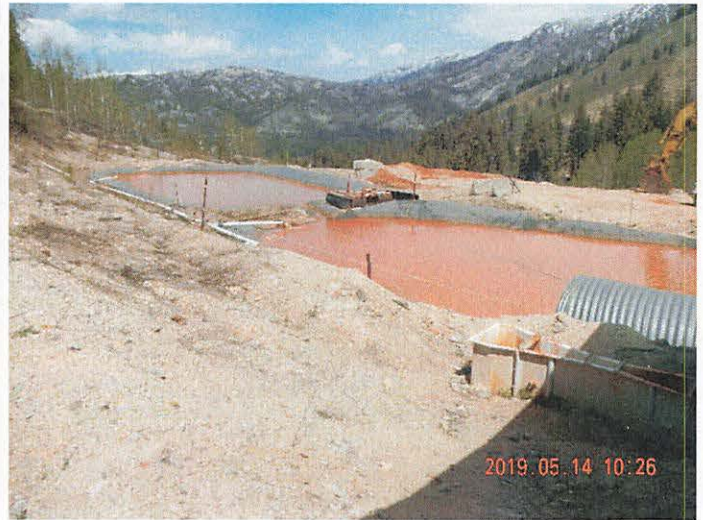
Photo #:14 (DSC1735)

Description: Facing north, photo of Pond #1 (North Pond), Pond #2 (South Pond).

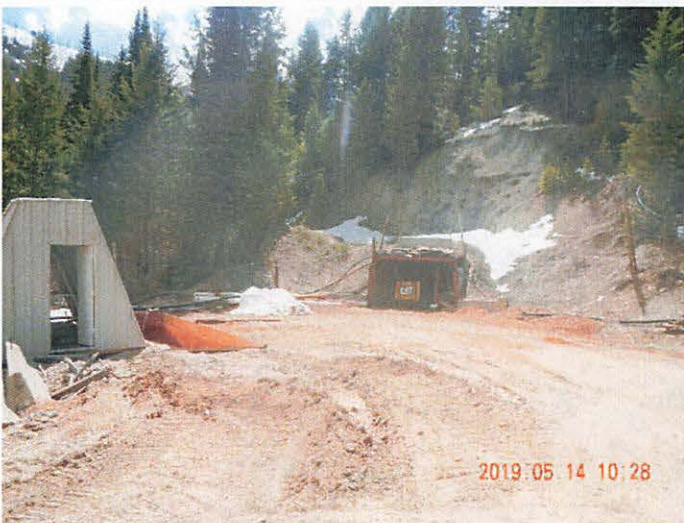
Photo #:15 (DSCN1736)

Description: Facing south, photo of the entrance to the 900 Level Adit.

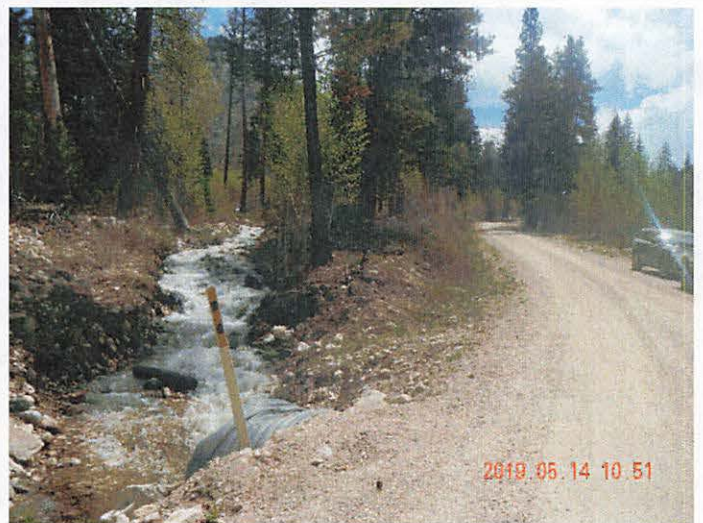
Photo #:16 (DSCN1737)

Description: Facing south, along Mine Hill Road north of the facility. Jim Inama originally thought the waterbody pictured was Montezuma Creek, following the inspection he confirmed it was East Montezuma Creek which combines with the facility's receiving water (Montezuma Creek).

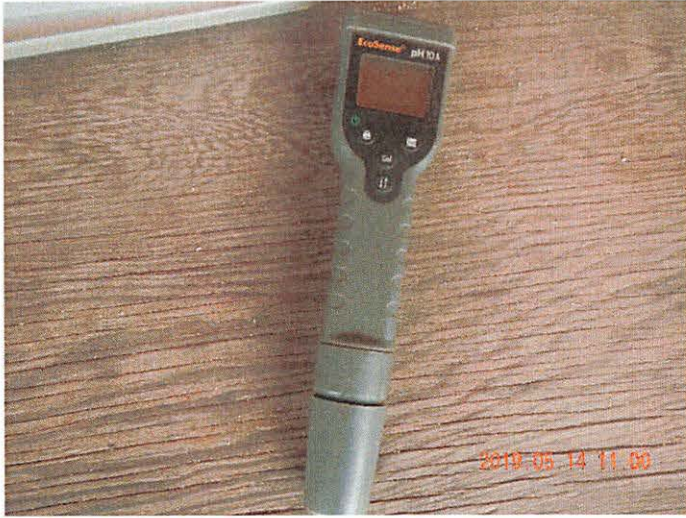
Photo #:17 (DSCN1738)

At the time of inspection, the facility was using an EcoSense® pH10A Meter for effluent monitoring. Mr. Inama stated that a 3-point calibration is conducted quarterly. I suggested to Mr. Inama that he review the manufacturer recommendation and the Quality Assurance Project Plan to confirm the required calibration frequency.

Description: Photo of the pH meter used at the facility, EcoSense pH 10A.

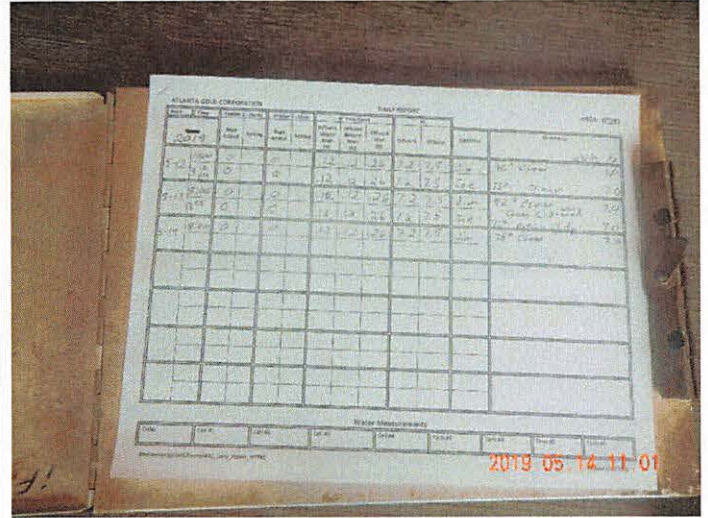
Photo #:18 (DSC1739)

Description: Photo of the "Daily Report" filled out twice a day, noting operator, time/date, pH, flow, quantity of additives, and weather.
